Crow Wing County Lakes Prioritization and Screening

2015

**Crow Wing County
Minnesota Board of Soil and Water Resources**

Crow Wing County Data Assessment Summary Report

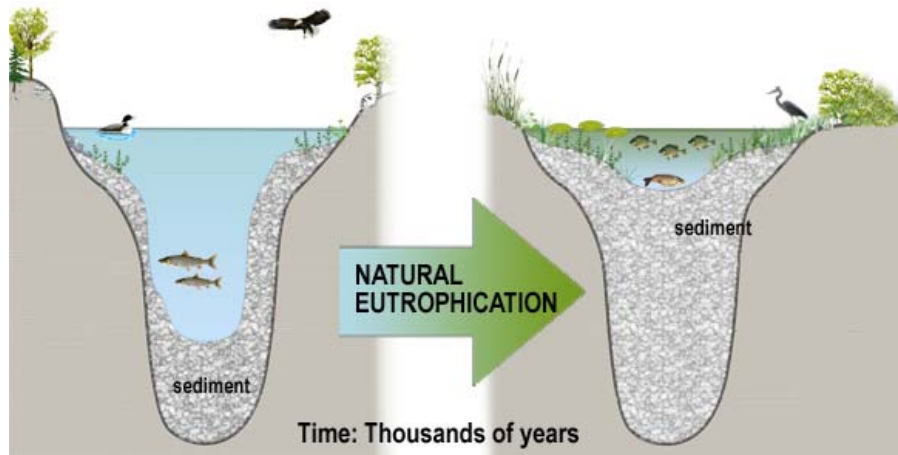
Humans can speed up the process of eutrophication by adding excess nutrients and sediment quickly, where the lake will change trophic states in a matter of decades instead of centuries. This type of eutrophication is called cultural eutrophication because humans cause it. We have changed the landscape around lakes, which changes their water quality and speeds up eutrophication.

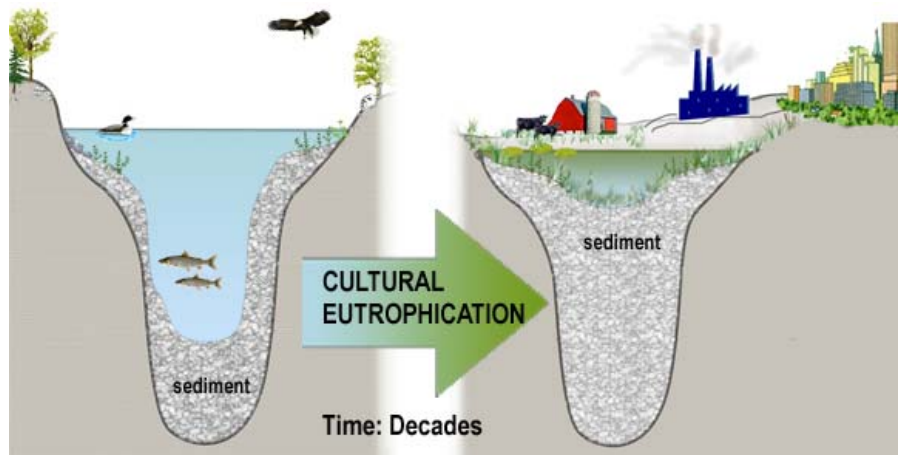
Around lakes, we have added a lot of impervious surface. Impervious surface is any surface on land that is impenetrable to water and prevents its absorption into the ground. Examples include rooftops, sidewalks, parking lots, and roads. The more impervious surface in a concentrated area, the less surface there is for rain to be absorbed into the ground. Instead, it ends up running into lakes and streams and carrying nutrients and sediment from the land it flows over.
